PRESIDENCY of CIVIL AVIATION

AIRCRAFT ACCIDENT REPORT

Saudi Arabian Airlines

Lockheed L-1011, HZ-AHK

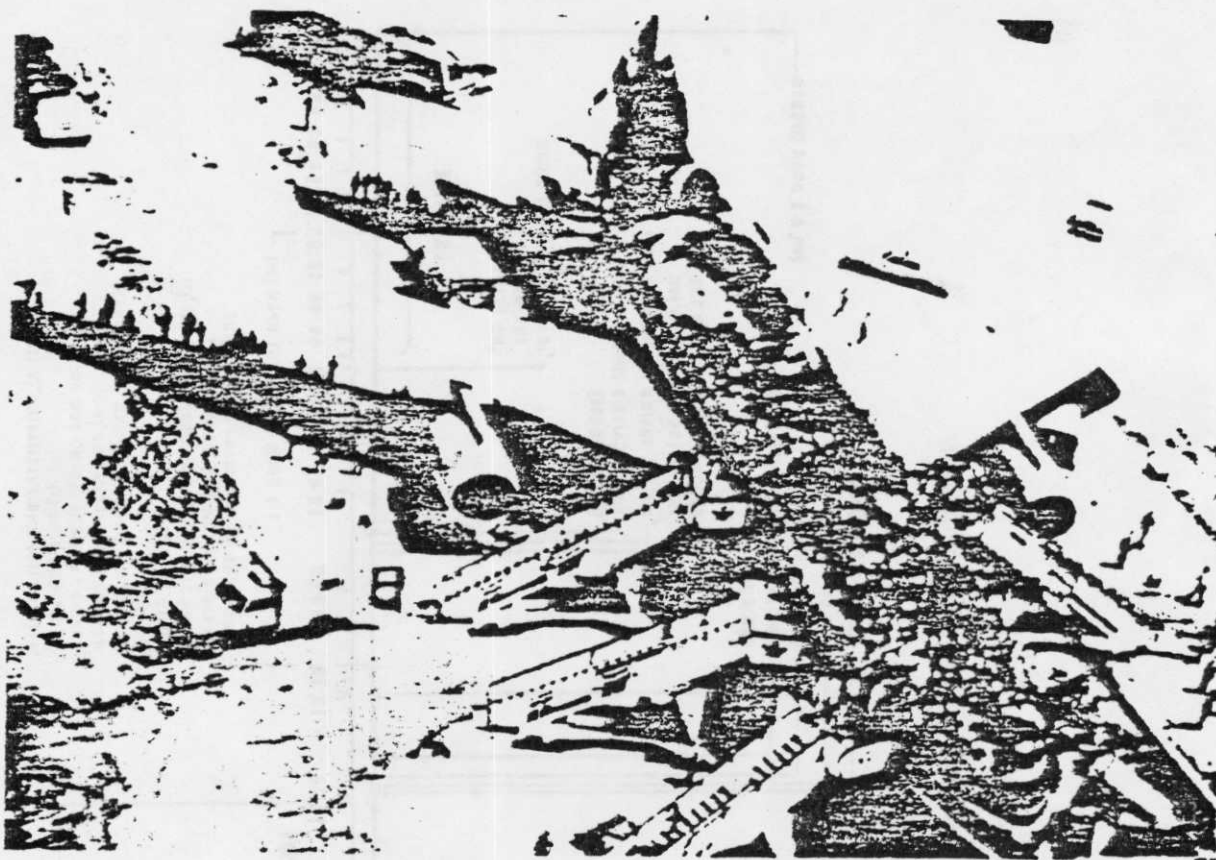
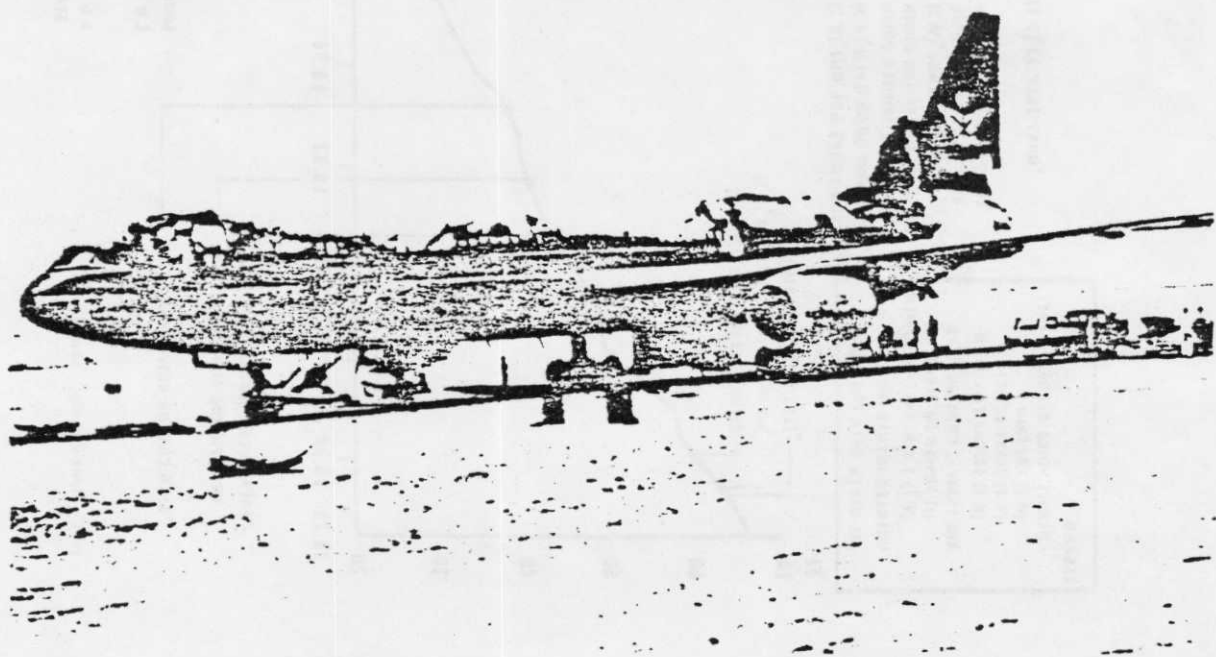
PHOTO NO. 1 - OVERALL VIEWS OF AIRCRAFT.

Attempts by the crash, fire, rescue personnel (CFR) to enter the aircraft and open the doors were unsuccessful until the No. 2 door on the right side of the aircraft was opened at about 1905, about 23 minutes after all engines had been shut down. At 1908, the fuselage interior was observed to be engulfed in flame. (see Figures 1, 2, and 3)

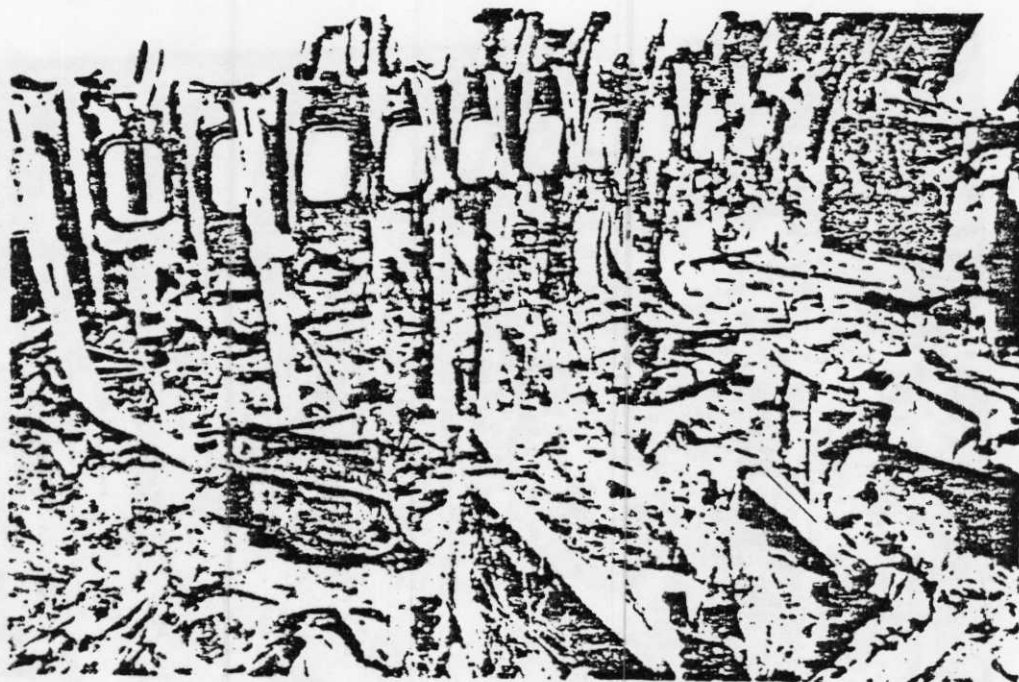
PHOTO NO. 2 - FLOOR COLLAPSE INTO
C-1 AREA

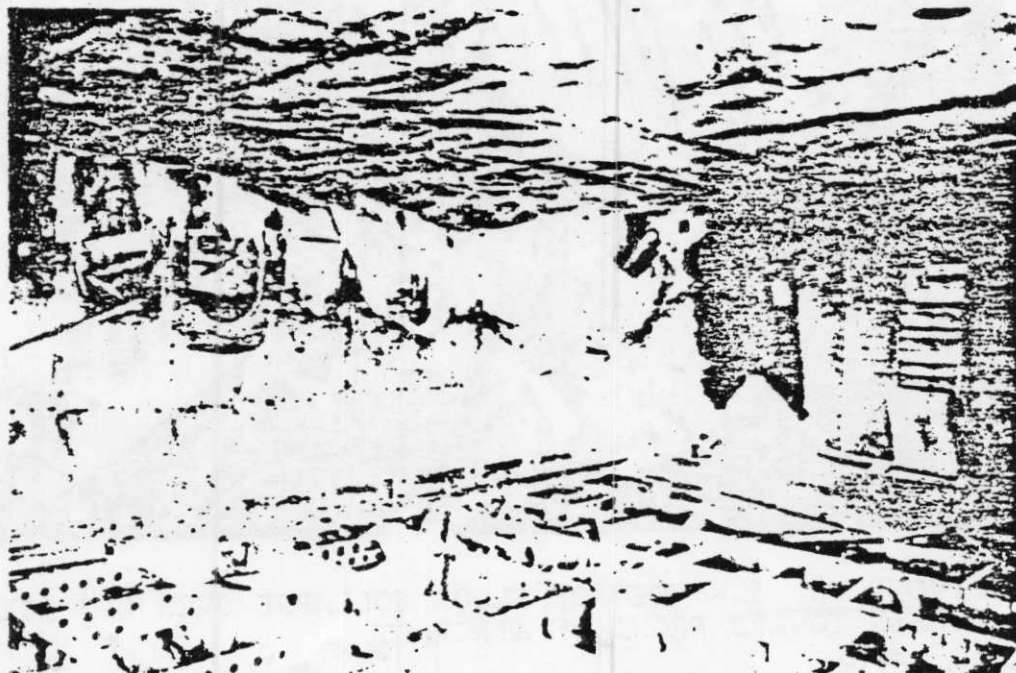
PHOTO NO. 3 - C-1 AREA FROM
INSIDE C-1 COMPARTMENT

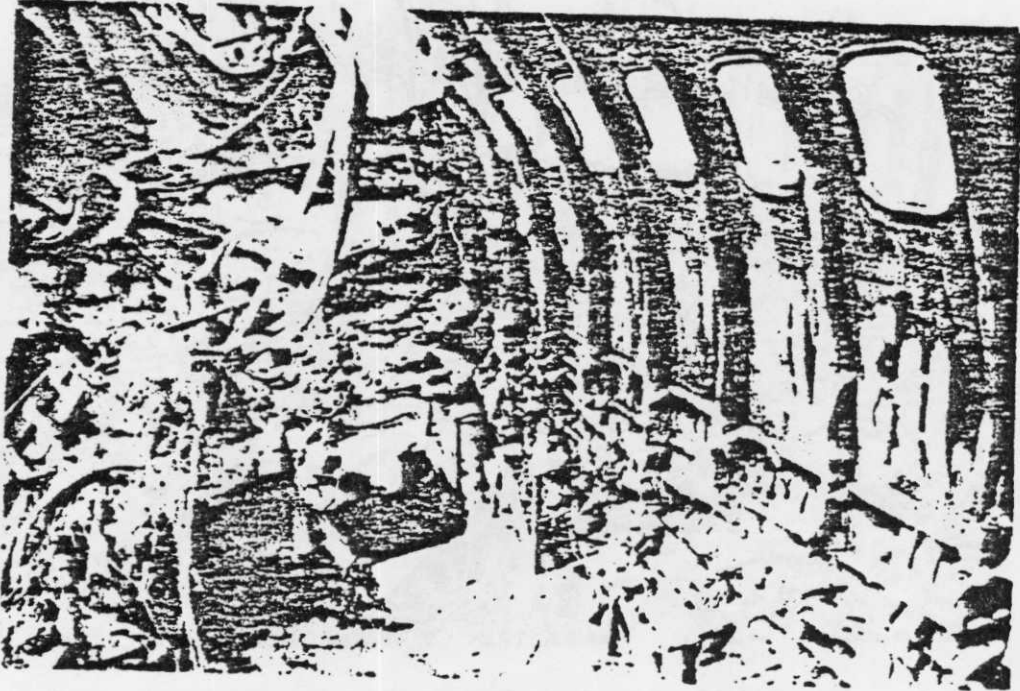
PHOTO NO. 4 - VIEW OF FLOOR COLLAPSE OVER C-3 AREA. TAKEN TOWARD AFT OF AIRCRAFT.

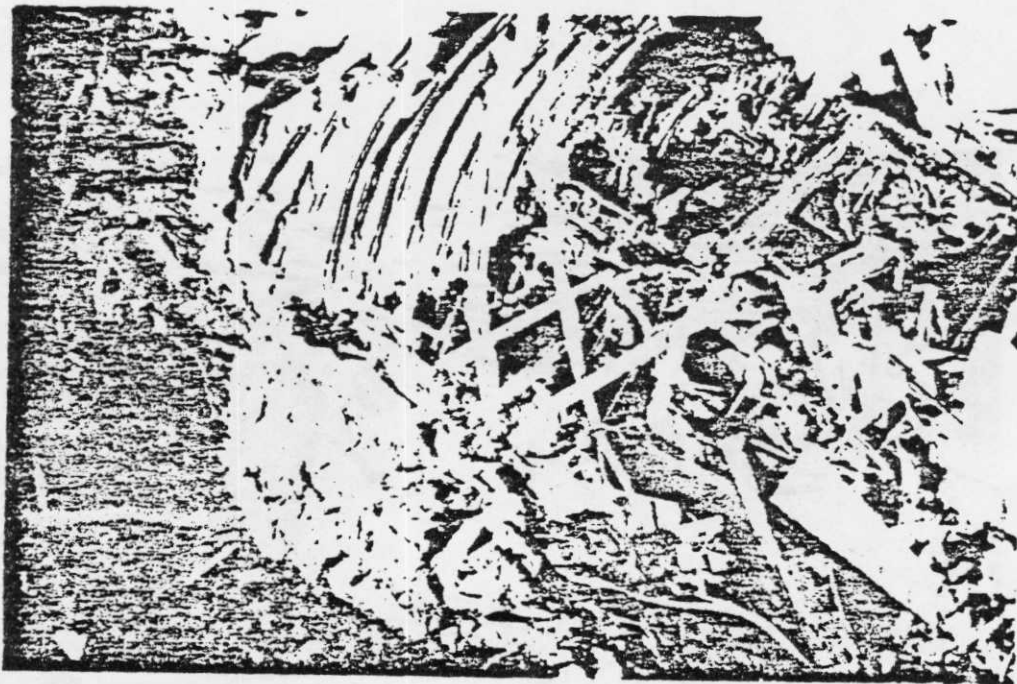
PHOTO NO. 5 - VIEW OF FLOOR COLLAPSE OVER C-3 AREA. TAKEN TOWARD FRONT OF AIRCRAFT.

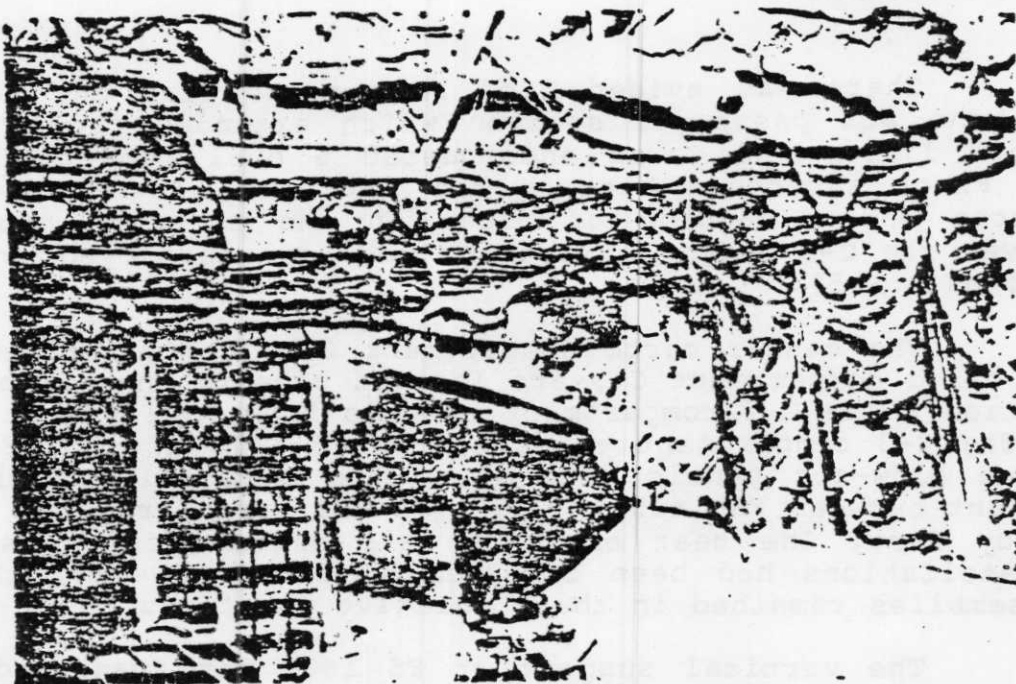
PHOTO 6 - C-3 COMPARTMENT. VIEW TOWARD AFT OF AIRCRAFT. NOTE COLLAPSED FLOOR AT REAR RIGHT.

The hole in the ceiling of the forward left side of the C-3 compartment extended from about FS 1675 aft to about FS 1725 and from BL 80 inboard about 40 inches. The cabin floor material above the hole was also burned away. The initial observation of the material surrounding the hole from the C-3 into the cabin revealed a "shingle" type pattern of the debris. That is, the material was burned away more at the bottom and less at the top generally in a tapered manner. Such a burn pattern indicates fire from the inside of C-3 burning upward and outward into the cabin area. (See Photos 6 & 7).

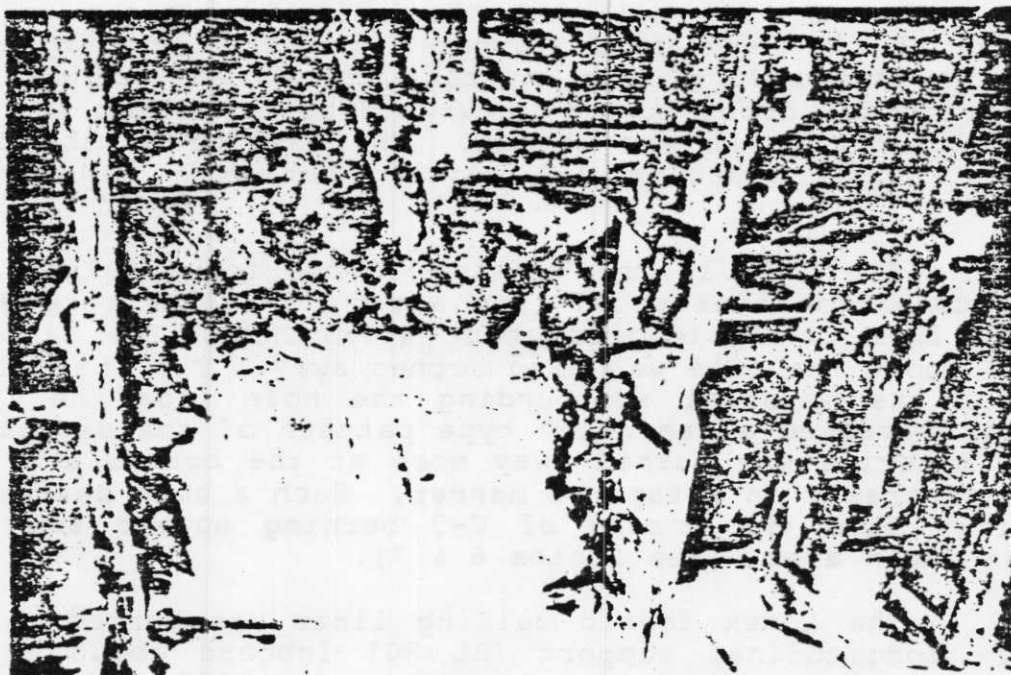
PHOTO 7 - C-3 COMPARTMENT. VIEW THRU HOLE IN FLOOR FROM C-3 AREA UP INTO LEFT REAR CABIN AREA.

A large hole was burned through the floor on the left side near the pressure bulkhead in the area of the aft lavatory installations.

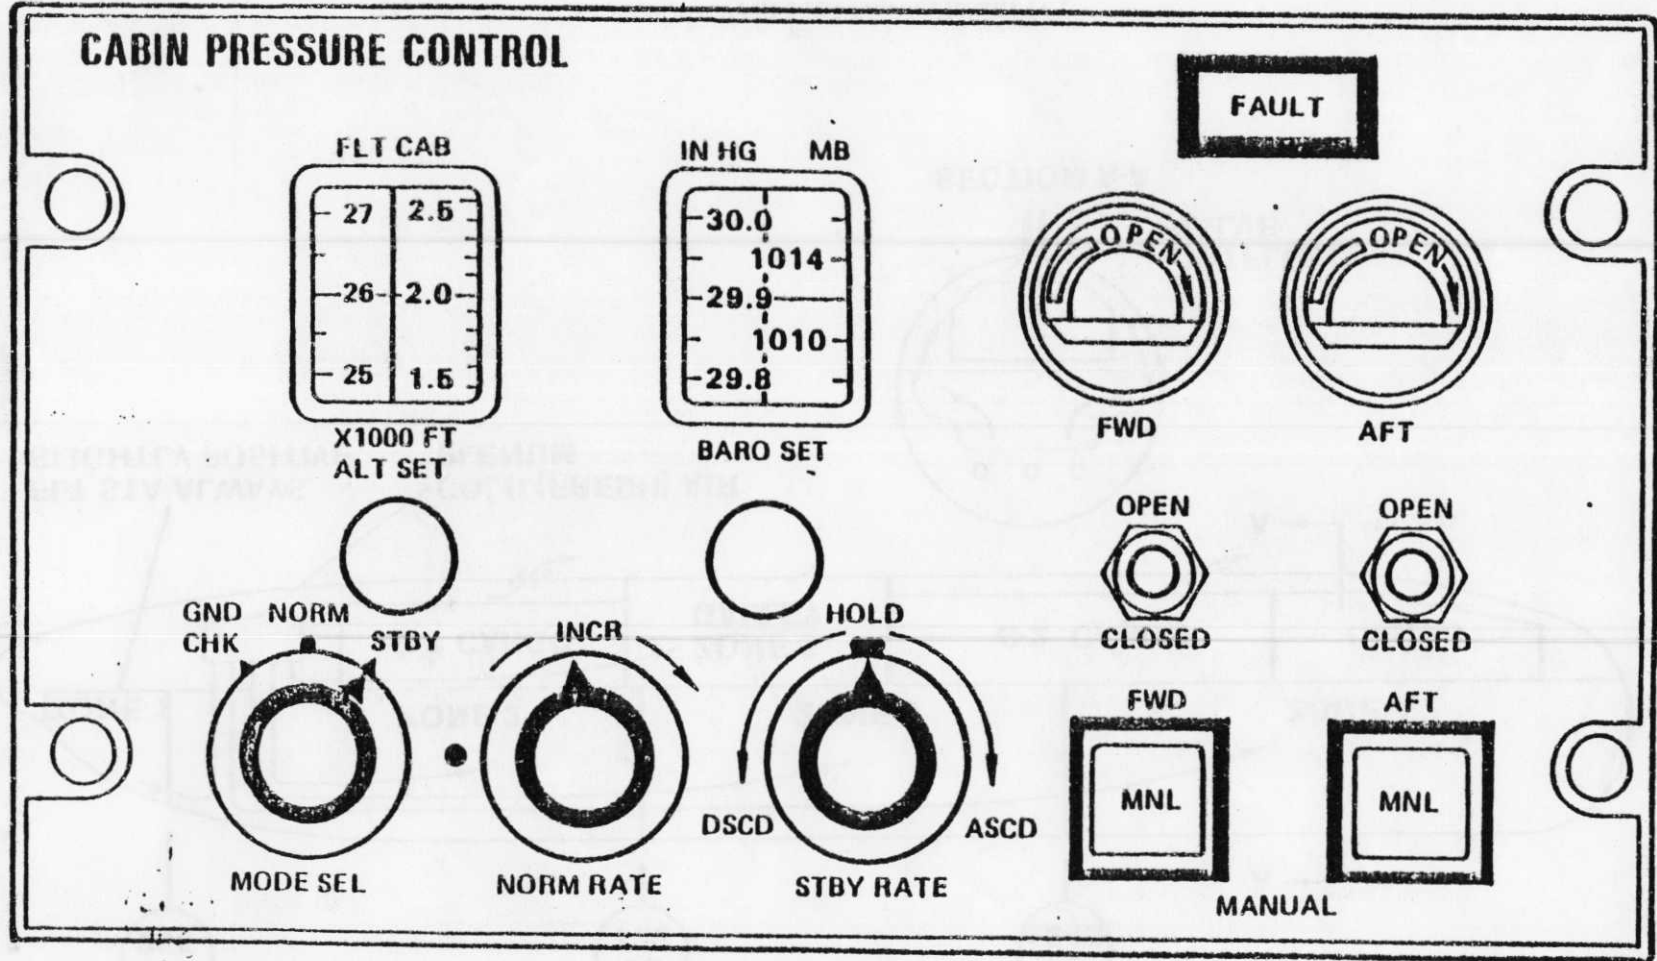
FIGURE 4

The cabin pressure control panel was recovered from the wreckage but was severely fire damaged. Some of the Indicator positions were found as follows (Figure No. 4):

1. Dials were burned off. Position determined by set screw location.
2. Switch was loose - may not be actual position at time of fire.
3. Switches, if depressed, will release if the Teflon detent latching system is destroyed.
